**Subject:** ABS and Stability control light illuminated

**Vehicles Involved:** 2008-12 Chevy Express/GMC Savana

**Condition:** DTC C0045 and/or C0050 stored in EBCM

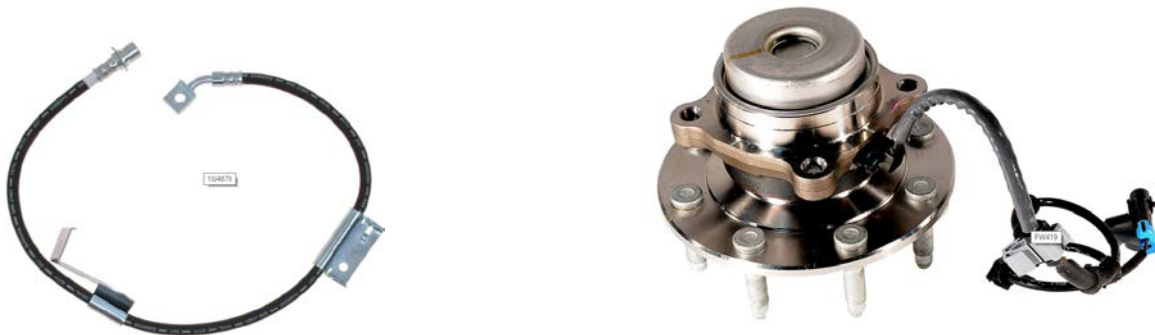
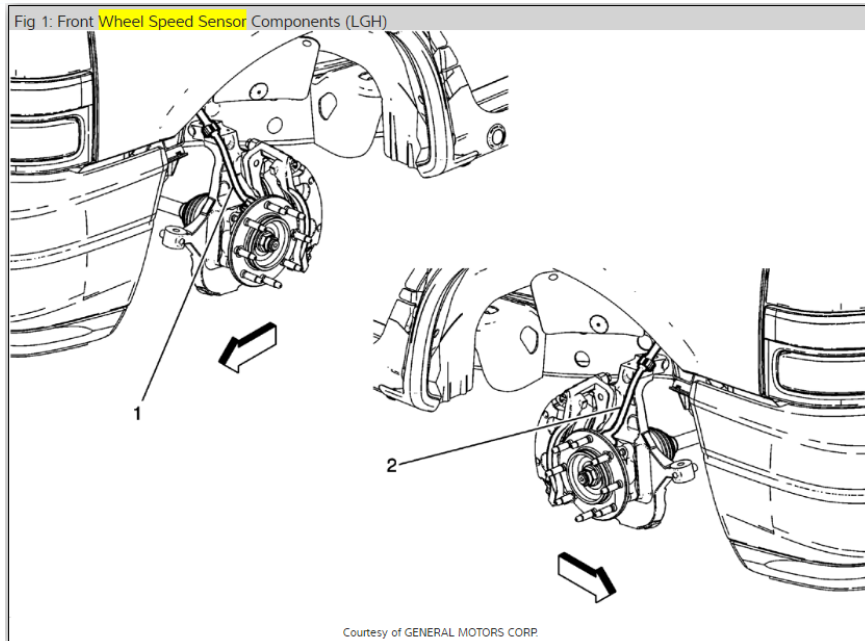
The most likely cause for this condition is the front wheel speed sensor harness being misrouted around the front brake hose. This issue may cause the harness to become too taut as it is routed through the suspension. As a result of this condition the wiring at the wheel speed sensor harness may pull out from the connector as the suspension moves up and down. The wheel speed sensor may require replacement. Be sure to route the harness parallel to the brake hose.
