## Bulletin BPI 17-08

**Subject: Rotor drum in hat rubs backing plate**

**Vehicle Involved: Subaru, Honda**

**Condition: Rust jacking behind backing plate**

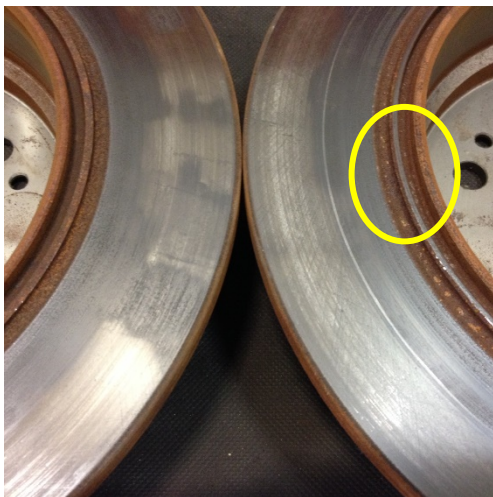
Fig 1

**Repair Procedure:** The tolerance between the backing plate and the lip of the drum-in-hat style rotor on the rear of many Subaru and Honda vehicles is very tight when new. If the vehicle is driven in the rust belt areas or anywhere they use corrosive materials on the roads for ice control, the rotor may start rubbing near the lip adjacent to the internal drum (fig1).

This is caused by “rust jacking” between knuckle and backing plate. If you see a shiny area (fig 2) on backing plate, you have this condition. The proper repair is to clean rust area and replace the bulging backing plate.
